**DATA SUMMARY**

Date and time	<b>Tuesday, 16 January 2007; 15:30 local time<sup>1</sup></b>
Site	<b>Tenerife South Airport</b>

Registration	<b>G-VCED</b>
Type and model	<b>AIRBUS 320</b>
Operator	<b>My Travel Airways</b>

Aircraft	<b>None</b>
Third parties	<b>Collapse of the platform on the boarding vehicle</b>

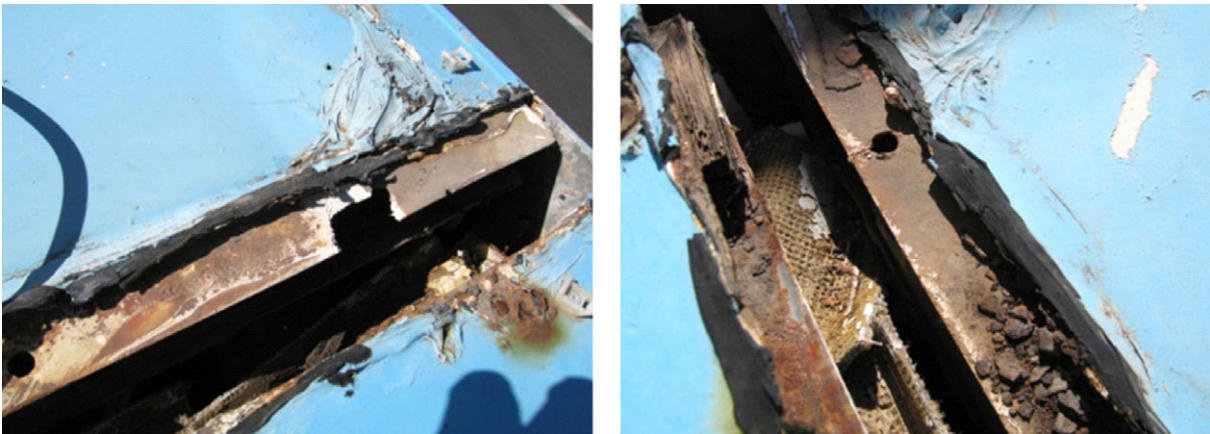
The platform that detached was fixed to the cabin of the passenger truck by a frame that was fastened by twelve rivets along the top horizontal part and another twelve on the sides, eleven of which were aligned vertically, with the twelfth forming a triangle with the two rivets at the top and in front of them. All were so corroded that some had completely worn away, while only the head remained of others. The rivets were nailed to the passenger cabin's wooden beams, which had completely rotted.

Figure 3. Close-ups of the cabin's top frame

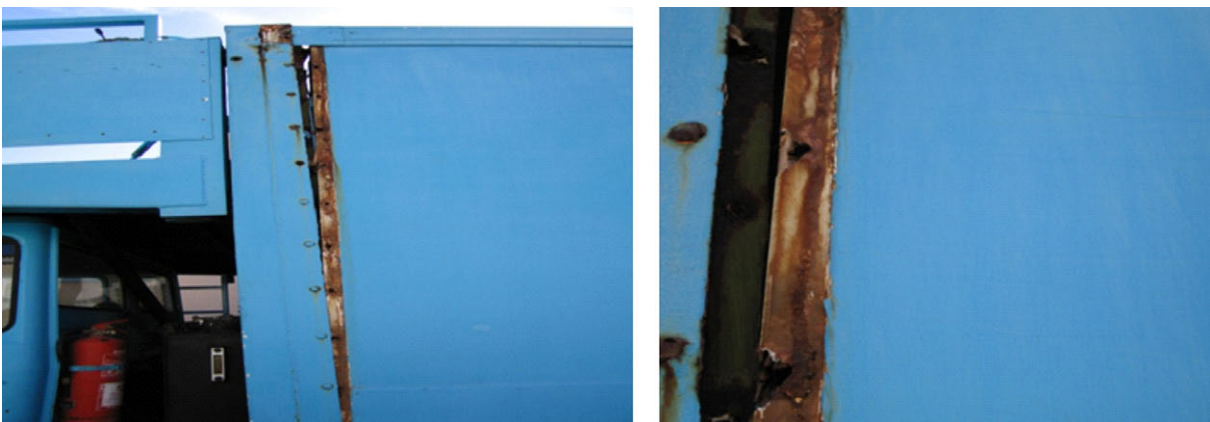
Figure 4. Close-ups of the cabin's left frame
